DEC Role: Regulate Vermont Rules & Memorandum of Understanding

- **Non-Radiological Investigation & Remediation**
 - **Site Investigation – Leachfield PFAS groundwater investigation (April/May 2024)**
 - **Post Demolition Surveys (part of investigation)**
 - **Advanced Off-Gas Building (January 2024)**
 - **AOC 11 – “New Warehouse” location (February 2024)**
 - **Corrective Actions**
 - **AOC 5 – former Diesel Oil Tank southwest of former Turbine Building (April/May 2024)**
 - **AOC 7a – former 75,000 gallon Fuel Oil Storage Tanks (April/May 2024)**
- **DEC Permitting**
 - **Drinking Water, Direct Discharge, Stormwater, River Alteration**

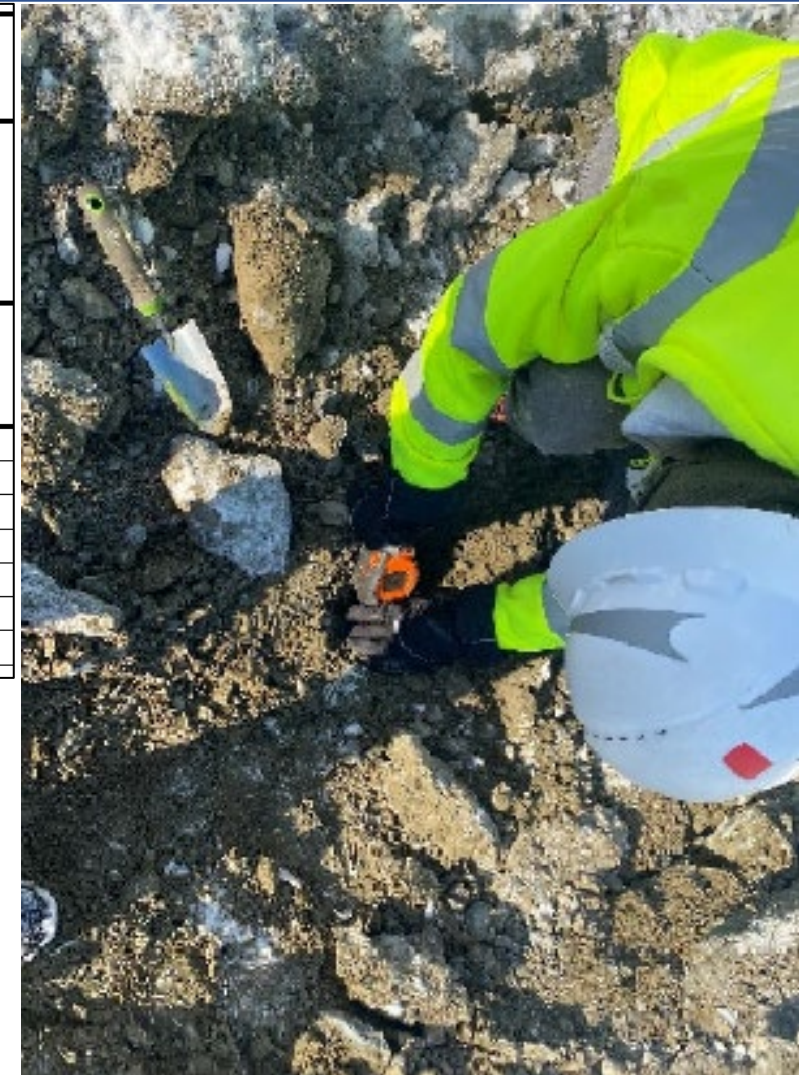
Advanced Off-Gas Building Area (Jan. 2024)

HALEY ALDRICH		HEADSPACE SCREENING REPORT				
PROJECT	Vermont Yankee Nuclear Power Station				H&A FILE NO.	
LOCATION	Advanced Off Gas Building (AOG)				PROJECT MGR.	
CLIENT	NorthStar Nuclear Decommissioning Co., LLC.				FIELD REP.	
INSTRUMENT	MiniRae 3000				DATE SAMPLED	
DATE CALIBRATED ⁽¹⁾	1/17/2024	LAMP (eV)	10.6		DATE SCREENED	
AMBIENT TEMPERATURE	~22°	CALIBRATED BY	ESD		SCREENING LOC.	
Exploration	Sample Number	Depth (ft)	Sample Description	Sample Reading (ppm) ⁽²⁾	Back-Ground Reading (ppm) ⁽²⁾	Remarks
HS-01	--	0-0.25	Brown C to F SAND, some gravel	0.0	0.0	No Staining or odor
HS-02	--	0-0.25	Brown C to F SAND, some gravel	0.0	0.0	No Staining or odor
HS-03	--	0-0.25	Brown C to F SAND, some gravel	0.0	0.0	No Staining or odor
HS-04	--	0-0.25	Brown C to F SAND, some gravel	0.2	0.0	No Staining or odor
HA-05	--	0-0.25	Brown C to F SAND, some gravel	0.0	0.0	No Staining or odor
HS-06	--	0-0.25	Brown C to F SAND, some gravel	0.0	0.0	No Staining or odor

HS-07	--	0-0.25	Brown C to F SAND, some gravel	0.0	0.0	No Staining or odor

- Contamination not expected, but located west of fuel pipes
- Conducted by H&A observed by Atlas Environmental
- No observed visual, olfactory, and PID evidence (7 locations)
- No evidence of Total Organic Vapors (TOVs)

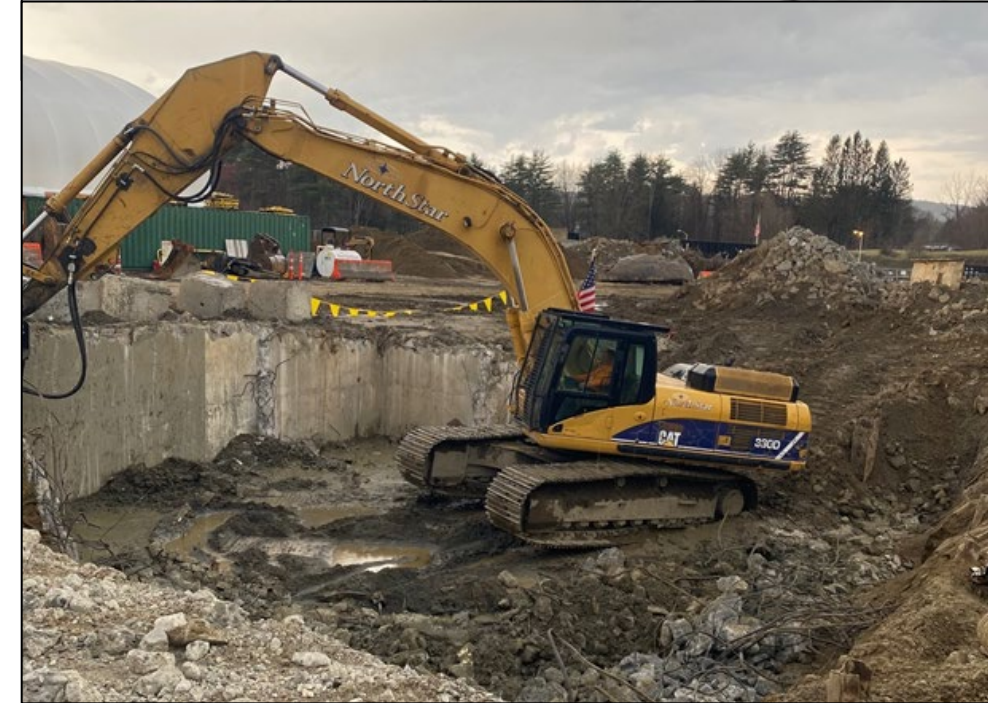
AOC 5 – Former Diesel Oil Tank (April/May 2024)

- Leak reported during plant operations, but too close to the building to remediate
- Soils excavated based on visual & PID readings, then clean boundaries sampled
- H&A collected 50 confirmatory soil samples from excavation sidewalls (including QA/QC)
- Atlas collected 6 split samples and 1 QA/QC
- Clean boundaries have been confirmed

- Excavation larger than expected (approximately 10,000 cubic yards ?)
- Approximately 3,500 cubic yards (?) impacted soil shipped to WCS
- Cut foundations to gain access to contaminated soil
- Non impacted soil stockpiled on concrete slab for radiological screening and potential reuse as backfill, after testing.

- Both AOC 5 & 7a areas to be backfilled following confirmation from the lab analyses that all impacted soils have been excavated.

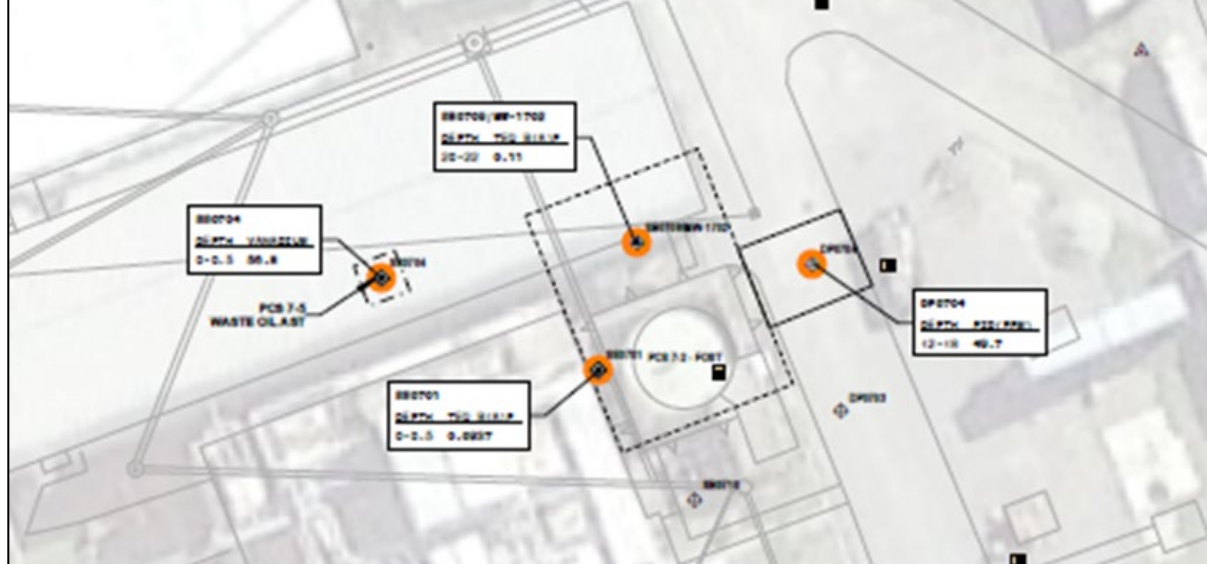
AOC 7a – former 75,000 gallon Fuel Oil (April/May 2024)

- Leak reported during plant operations, but below the tank vault (inaccessible)
 - Initial remediation excavation complete
 - H&A and Atlas took confirmation samples last week (May 9, 2024)

- Waiting on laboratory results
-

- The site map displays an aerial view of an industrial facility with several key features and data points. A central circular tank is labeled 'WATER TANK'. To its left is a rectangular area labeled 'WASTE OIL AST'. Four orange circular markers indicate sample locations, each with a callout box: 'BB0704 DEPTH: VARIOUS 0-0.5 00.8', 'BB0701 DEPTH: TOU SLIP 0-0.5 0.007', 'BB0702 DEPTH: TOU SLIP 20-22 0.11', and 'BB0704 DEPTH: BELLBELL 12-18 40.7'. A dashed rectangular boundary encloses the central tank and the two sample points BB0701 and BB0702. Other labels on the map include 'PCB 7-0', 'PCB 7-0-POST', 'PCB 7-0', 'DHW13', and 'DHW14'.
